Accessible cross-border travel programme in the SI-HR-HU region

Slovenia - Croatia - Hungary

February 2026
Final report

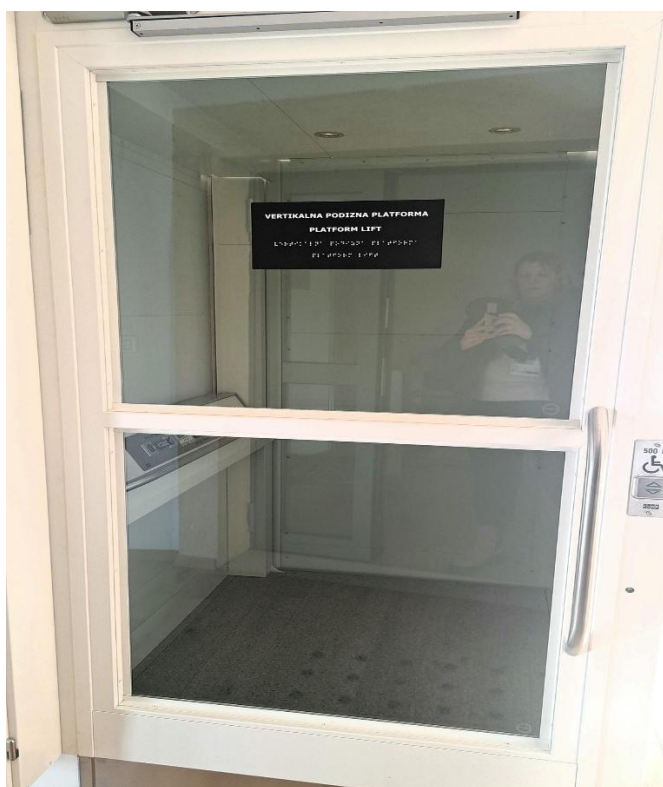
Figure 2: Text in Braille

The museum has a systematically implemented accessibility system. Braille signage is available for blind and visually impaired visitors. Exhibition content is adapted for deaf and hard-of-hearing visitors. Interpretation is inclusive and follows high accessibility standards.

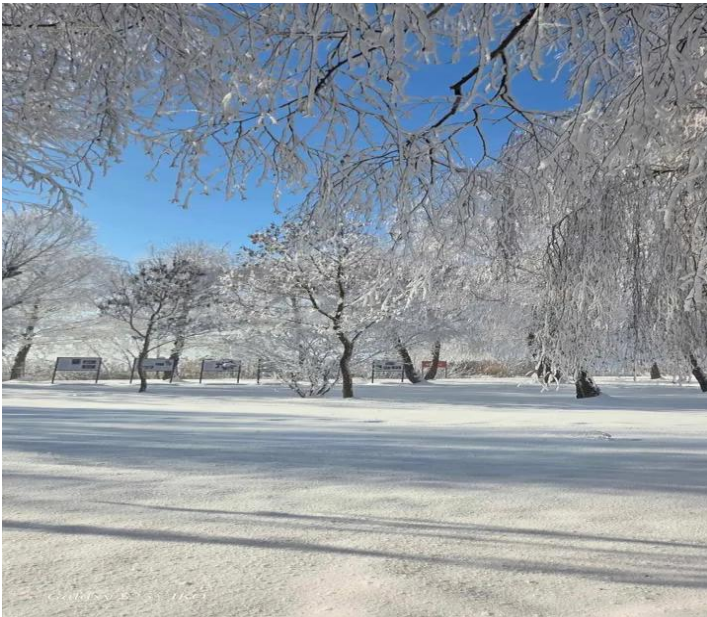
Figure 4: Marina outdoor

The parking area has been asphalted, significantly improving vehicle access and transfer from vehicle to wheelchair.

The promenade surface consists of gravel, which makes independent wheelchair movement difficult. While the location is attractive and arrival is accessible, the

promenade itself requires assistance for wheelchair users. Asphalted sections near the facilities can be used as an alternative.

Accessible arrival; limited independent outdoor mobility.

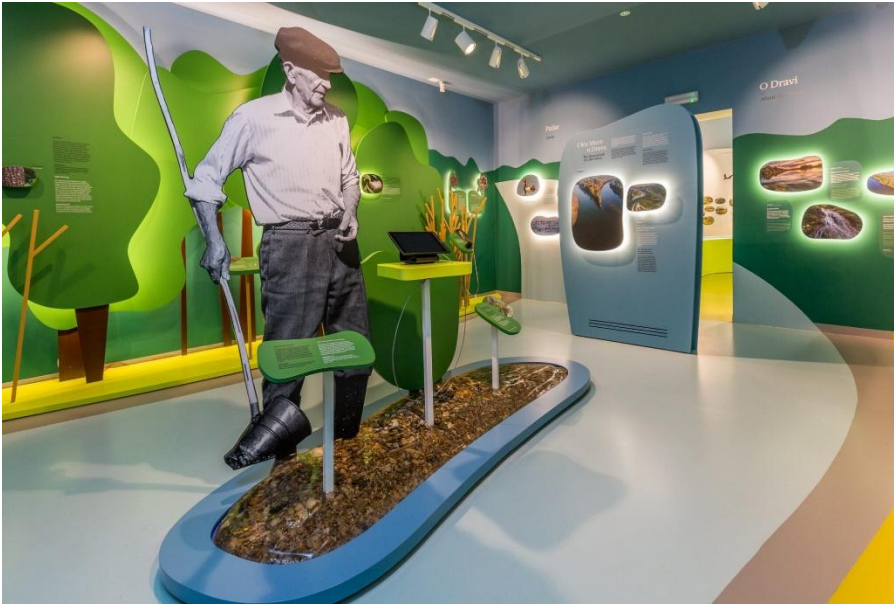
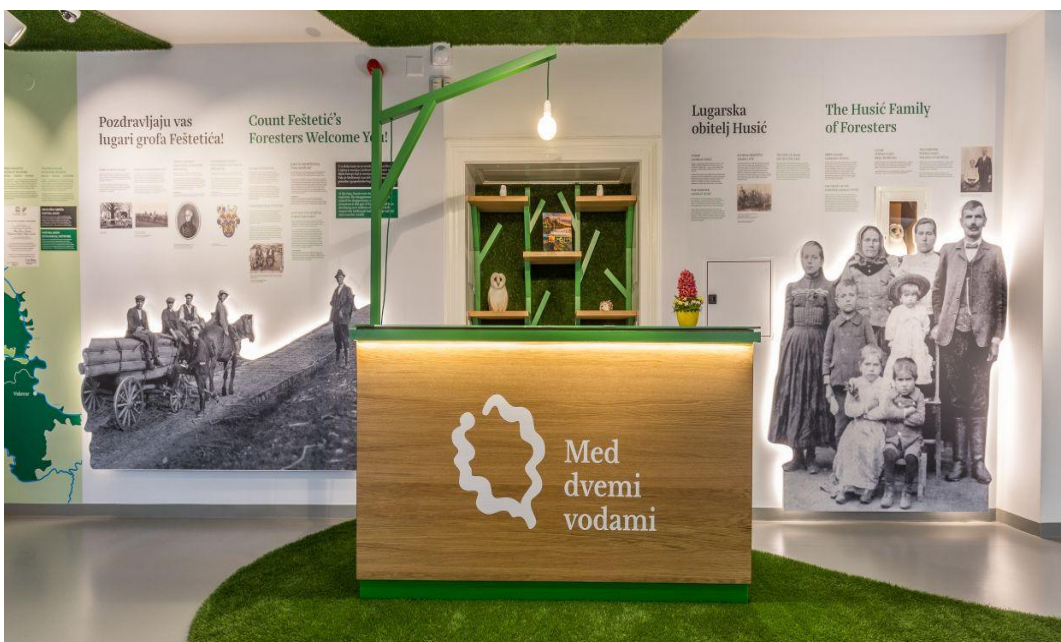
Figure 5: Museum Med dvemi vodami

The centre is accessible. All parts of the multimedia exhibition are easily reachable by wheelchair users.

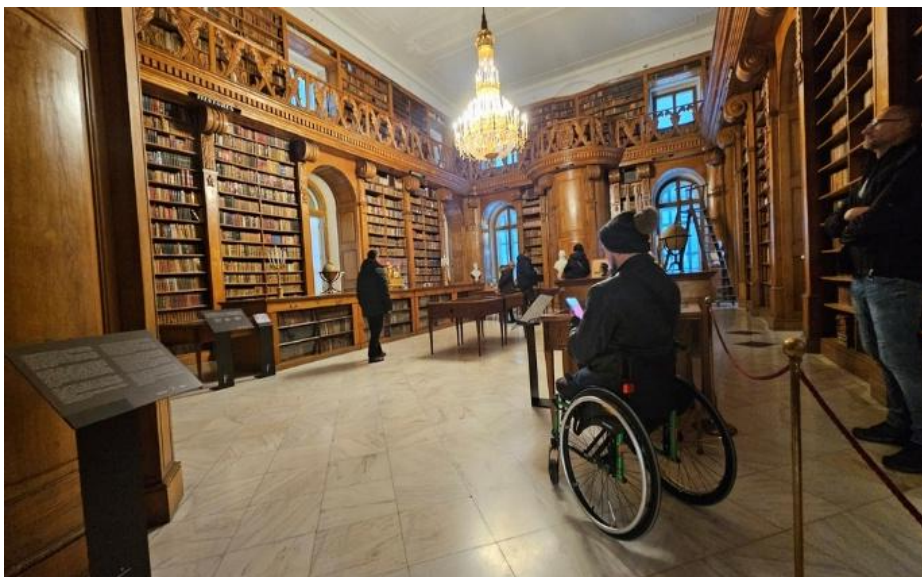
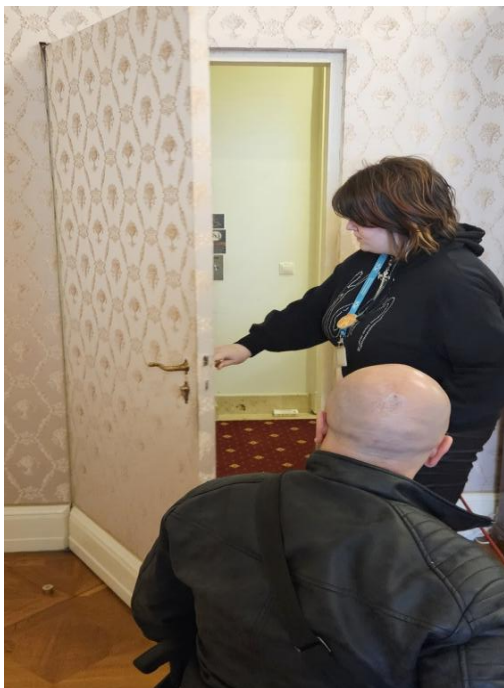
Figure 8: Guidance in the museum

The building includes an elevator providing direct access to the exhibition areas, enabling barrier-free visits.

Accessibility signage is available only for the toilet and souvenir shop. There are no Braille inscriptions or assistive devices for visually impaired visitors.

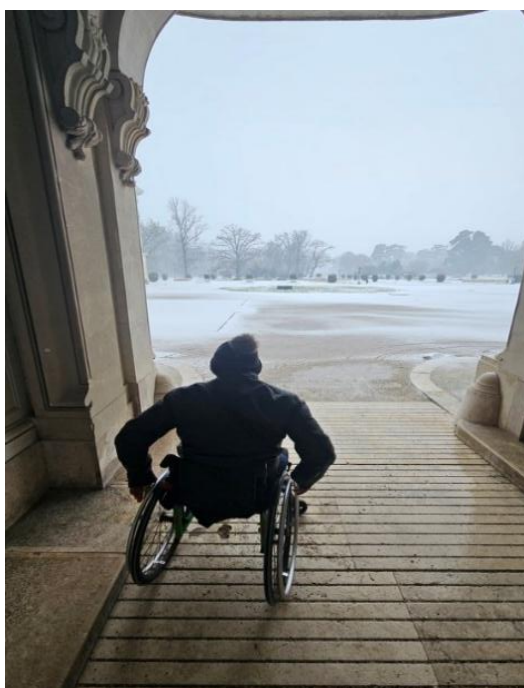
Figure 9: Entrance to the park

The route from the parking area is gravel but allows wheelchair movement.

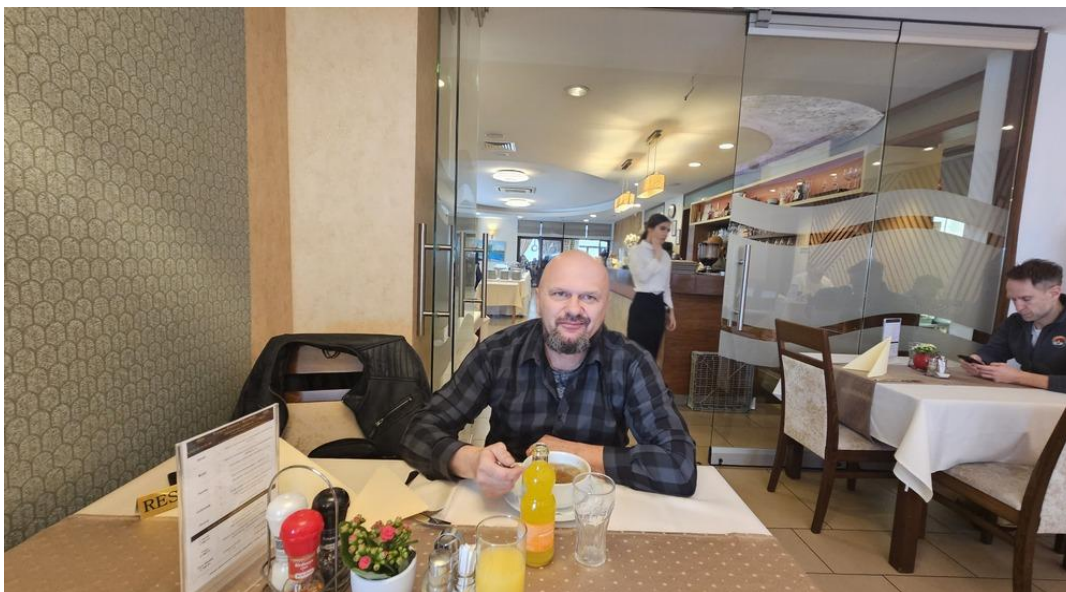
Figure 10: Restaurant area

The entrance and interior are level and barrier-free.

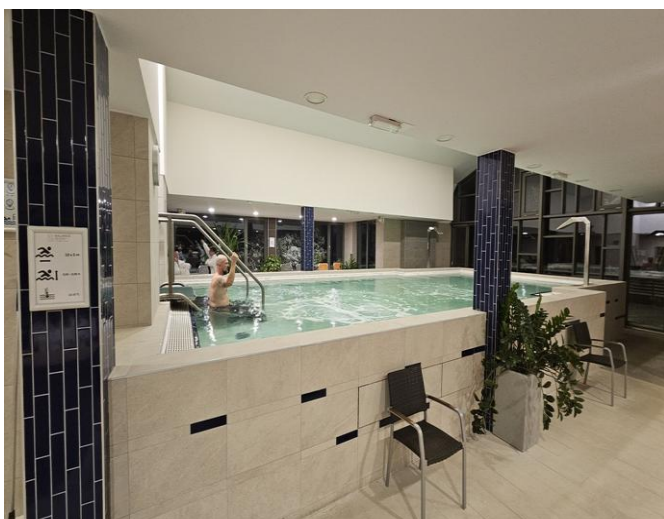
Figure 12: Hotel pools

Wellness Area:
The wellness space is accessible; however, entry into the pool is not possible independently due to stairs. There is no ramp or pool lift available.

Accommodation facilities demonstrate an overall good level of structural accessibility, particularly in common areas such as receptions, corridors and restaurants. However, certain functional gaps were identified within guest rooms and wellness areas. The absence of pool lifts in wellness facilities prevents independent access to water for wheelchair users, which limits full participation in the wellness experience. In addition, the lack of shower chairs and properly installed grab bars in some bathrooms reduces functional autonomy and may require assistance. These elements are essential not only for compliance with accessibility standards but for ensuring real usability and independence.

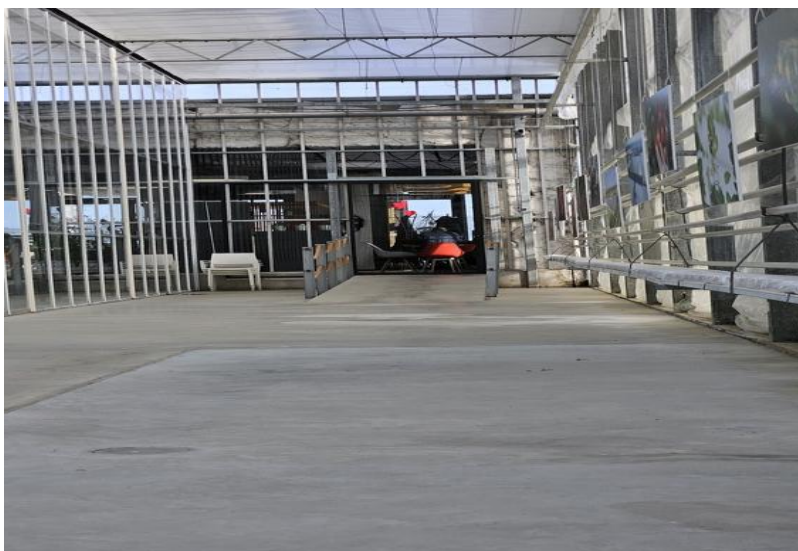
Figure 14: Greenhouse

Fully accessible entrance, interior spaces and sanitary facilities.

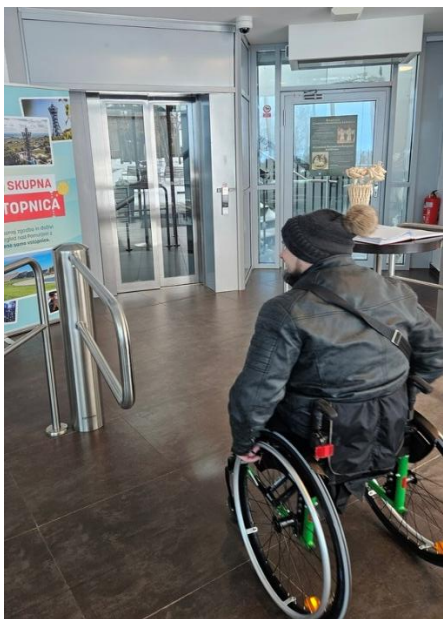
Figure 16: Entrance to the elevator

Fully accessible and barrier-free. Elevator provides access to observation level.

Well marked, with separate elevator entrance.

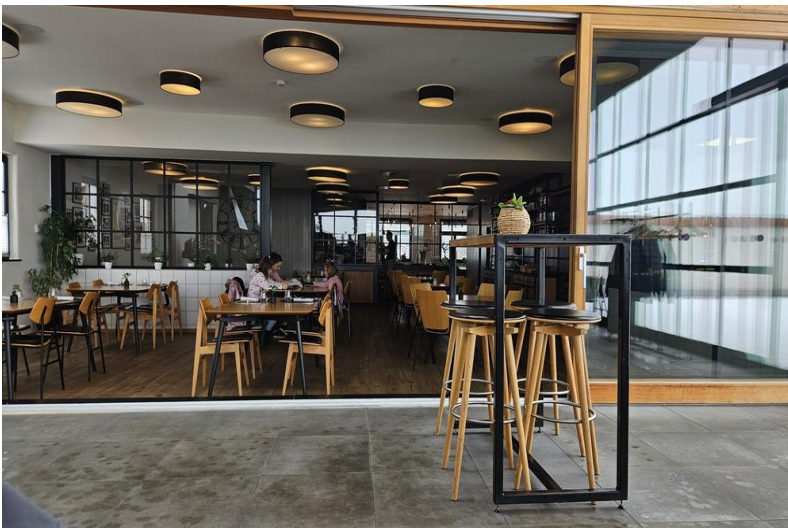
Figure 18: Restaurant area

Internal stairs divide the dining area, making part of the restaurant inaccessible to wheelchair users.

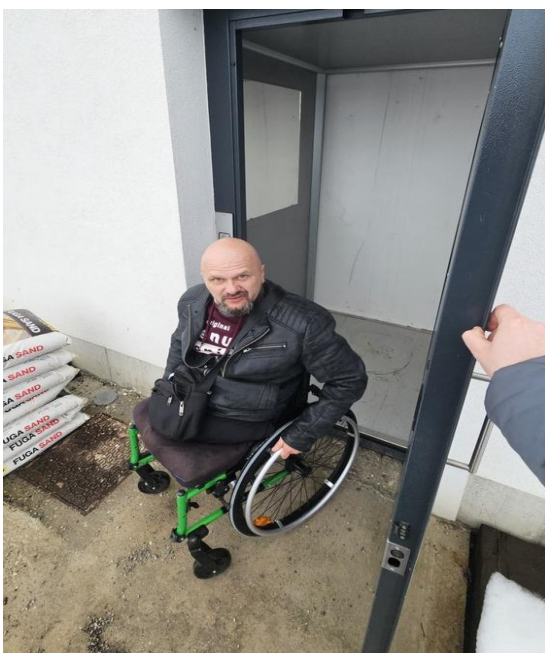
Figure 19: Entrance

The restaurant is located on the upper floor and accessible via elevator.

Communication Accessibility:
No signage directing guests to the elevator, which is located at the back of the building.

Assessment:
Accessible with minor internal layout limitations; improved signage recommended.
